Technical Bulletin

Subject: VWC Remanufactured 2.0l Air-Cooled Engine **Group:** 10

Number: 10-90 T01

Models(s): Type II/Vanagon 1975 - 83 MY **Date:** May 31, 1990

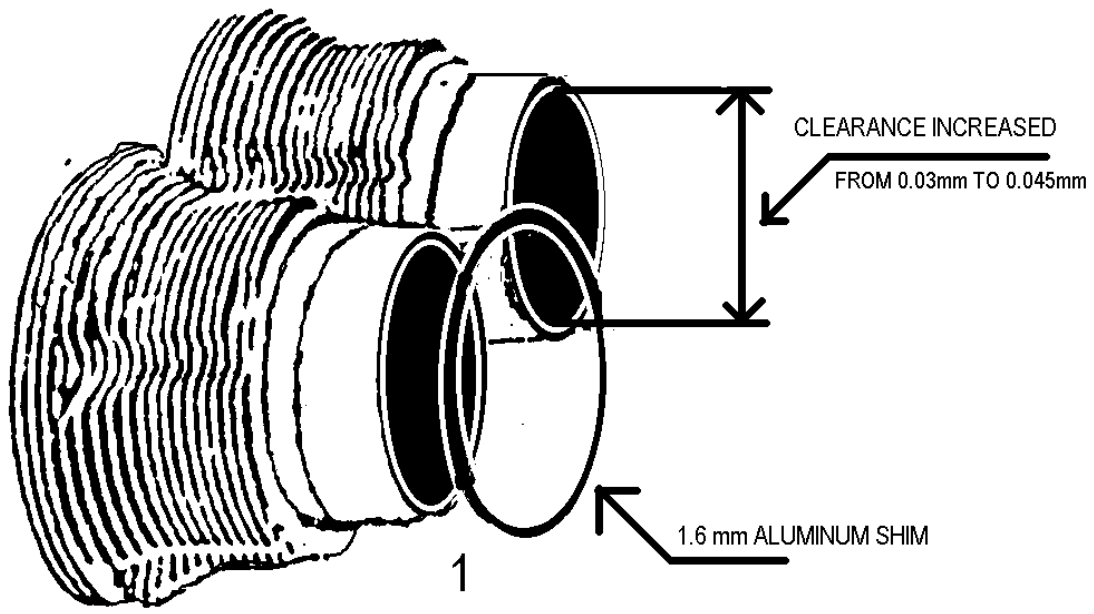
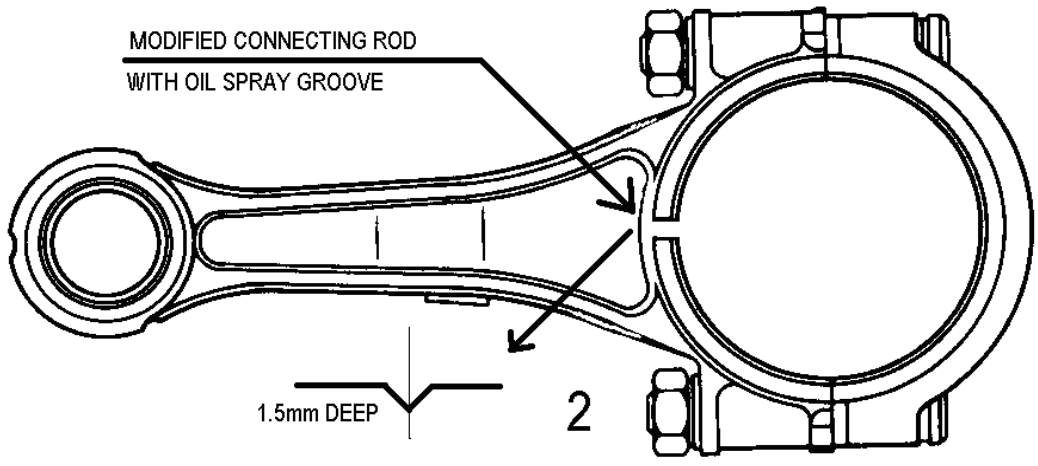
1. To eliminate seizing of pistons, increased piston/cylinder clearance from $0.03\text{mm} \pm 0.008\text{mm}$ to $0.045\text{mm} \pm 0.005\text{mm}$.
2. Eliminate aluminum seal 021 101 341A between cylinder and cylinder head.
3. Eliminate paper gasket 021 101 341A between foot of cylinder and crankcase.
4. Install 1.6mm aluminum shim 071 101 341, with adhesive D 000 400 at foot of cylinder to compensate for removed paper gasket and aluminum seal. Illustration 1.
5. To improve heat transfer, oil grooves on both sides of the connecting rod to allow oil splash to cool bottom of the piston. Illustration 2
